Marian MARSCHALKO¹, Libuše HOFRICHTEROVÁ², Lubomír TŘESLÍN

**ENGINEERING-GEOLOGICAL CONDITIONS OF LANDSLIDE IN THE OSTRAVA-KARVINÁ
COALFIELD**

The paper deals with a slope deformation Staříč (sequence number 2) in the Frýdek Místek district in the north-east of the Czech Republic. It makes part of a wider three-year study, which comprises 6 localities of slope movements in total (sequence numbers 1 to 6) in the Ostrava-Karviná District, in case of which there is a potential precondition for changes in stability due to undermining. In the first phase, archive materials, basic data, aerial photographs of slope deformation were studied and evaluated. Subsequently, engineering-geological mapping were performed, on the basis of which all landslide manifestations, such as starting scar, cracks, layer outcrops, hydrogeological structures etc. were recorded. After this phase, resistivity tomography measurements (geophysical method of multielectrode resistivity measurement) were taken. The mentioned methodology was applied in the interest area for the first time.

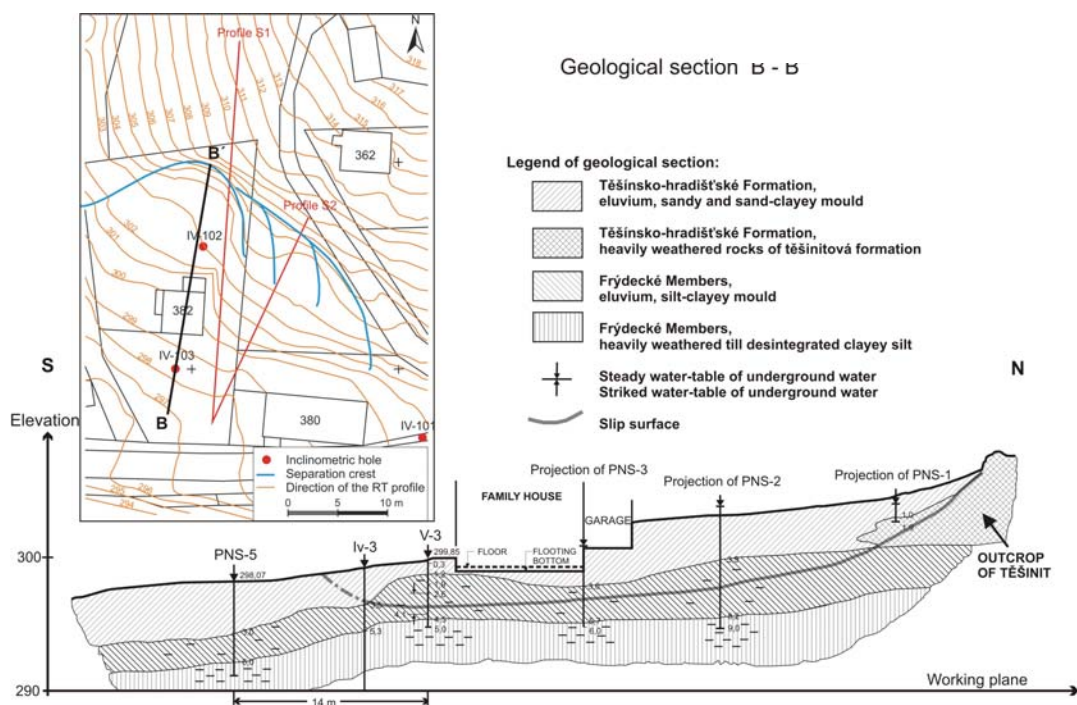
In the interest locality it is possible to interpret the following geological section on the basis of a *previous archive survey works* and *engineering-geological mapping* (Figure 3).

Fig. 3: Geological section and map of the interest area along with the sections placement

The interpretation of the slip surfaces of *S1 section* (Figure 11) was mainly conditioned by morphology, by means of top tear edge manifestation, and next by inclinometric measuring in the bores Iv-102 and Iv-103 (bore placement – Figure 3). According to the inclinometric measuring in the bore Iv-102 an occurrence of a slip surface was proved in the approximate depth of 6-7m under the collar of well and the slip surface depth identified in the bore Iv-103 was about 3 m p. t. (under the ground). Inclinometric measurements register both movements caused by undermining in the direction of the subsidence trough as well as movements related to a slide.
